**Assmann
Corporation®**

Polyethylene Tank Inspection Guide

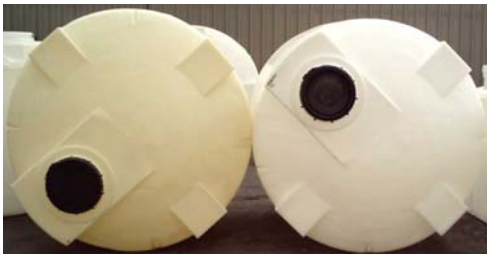
The picture on the right is a Linear HDLPE tank: Notice the "White color". Linear PE is a weldable, FDA approved material. Used commonly for day tanks and small chemical feed applications.

On the left, is a Crosslink HDXLPE tank: Notice the "off White / Yellow color". Crosslink polyethylene is used for large industrial bulk storage applications.

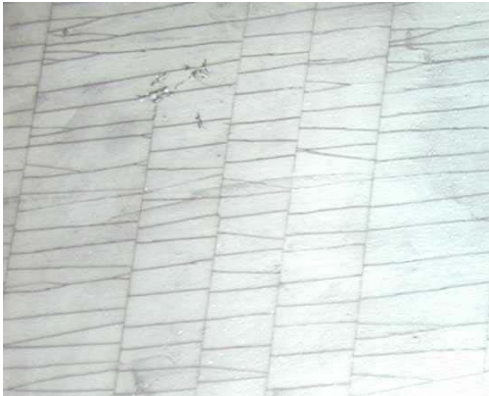
Over-exposure to Ultra-violet rays is pictured below. Quality polyethylene resins are compounded with Ultra-violet stabilizer prior to being distributed to the tank manufacturer's facility.

Common in the industry, tank manufacturers reduce wall thickness by using less resin in the upper sidewall and dome of the tank. This makes the tank roof more susceptible to ultraviolet damage. Assmann polyethylene tanks are constructed with uniform-wall thickness from top to bottom. This added thickness gives additional protection to Ultra-violet exposure and extends the service life of the tank.

Tanks that are installed in areas that have extreme amounts of UV exposure should be sheltered from the environment, insulated or colored for additional protection.

A common test method to see if your tank has undergone Ultra-violet attack is to use water based stain or marker and color in a small area that has been exposed to sunlight. This will fill any voids in the polyethylene material making cracks visible. Areas to check are the dome and lower sidewall of the tank.

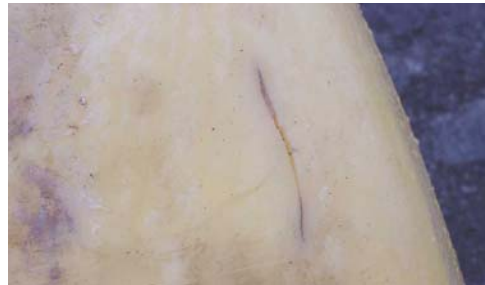
Polyethylene tanks are the most corrosion resistant method for storage of harsh chemicals. Improper plumbing attachments, Chemical and UV attacks are the most common causes for failure. Tanks can also fail due to age. Pictured below is a polyethylene tank that failed due to age. As you can see in the picture this tank has cracked a few inches above the tank floor. Typically cracks will develop near the tank base where the tank expands and contracts under normal operating conditions. When inspecting a tank always look near the tank's knuckle radius.

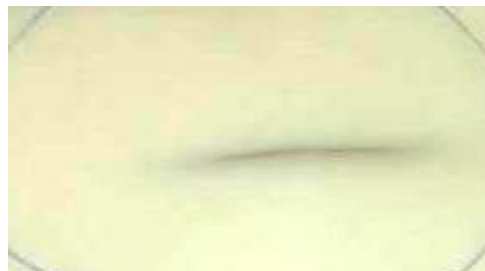
This picture is a chemical stress crack in a Crosslink polyethylene tank. Stress cracks normally develop at or near tank sidewall connections. A Crosslink tank will typically develop a stress crack prior to complete tank failure. This gives the end user warning to get the tank removed from service. Normally a Linear polyethylene tank will not give this type of warning before complete failure.

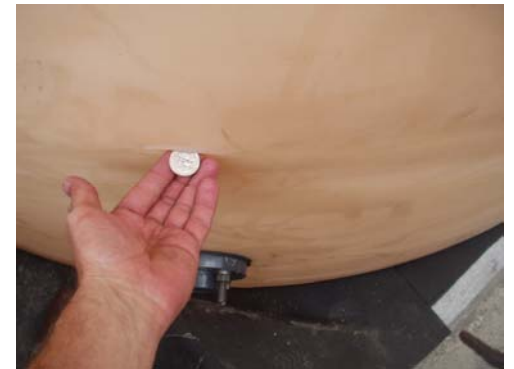
Polyethylene tanks are most commonly damaged when they are in transit or being off-loaded at a customer's site. Pictured below is a tank that has been gouged. This customer is using a quarter to gauge the penetration into the tank. If you can provide an accurate depth of a gouge, a reputable manufacturer can calculate the remaining thickness of the tank and give recommendations on how to proceed. A tank manufacturer or a qualified representative should be contacted immediately when damage is found.

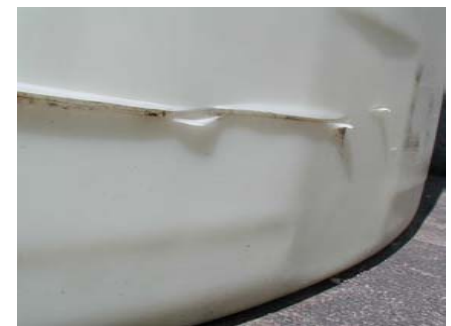
Tanks with damage similar to the picture shown below should be reported to the manufacturer, and evaluation should take place prior to the tank being placed in service.
